## **DWELLING STRUCTURES IN THE CYCLONE PRONE COASTAL AREA: A CASE STUDY OF BURIRCHAR, BARGUNA**

**Syed Anowerul Azim\***

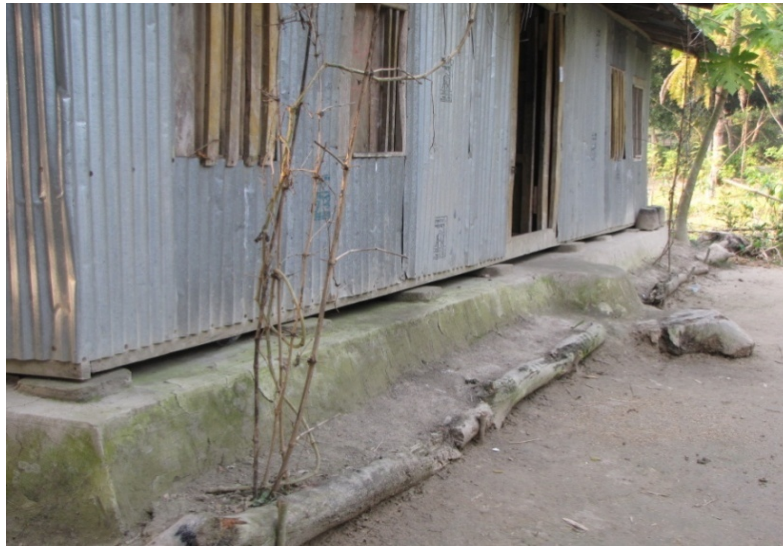
**Photo 1:** Floating pillar of a House

Here one thing is very important that rest of the houses' pillar is floating. They float their pillar on the block (cement) on the floor. The respondents replied that if they dig the pillar (wooden pillar) then it would be decay in very soon. They float the pillars on a piece of cement block on the floor.

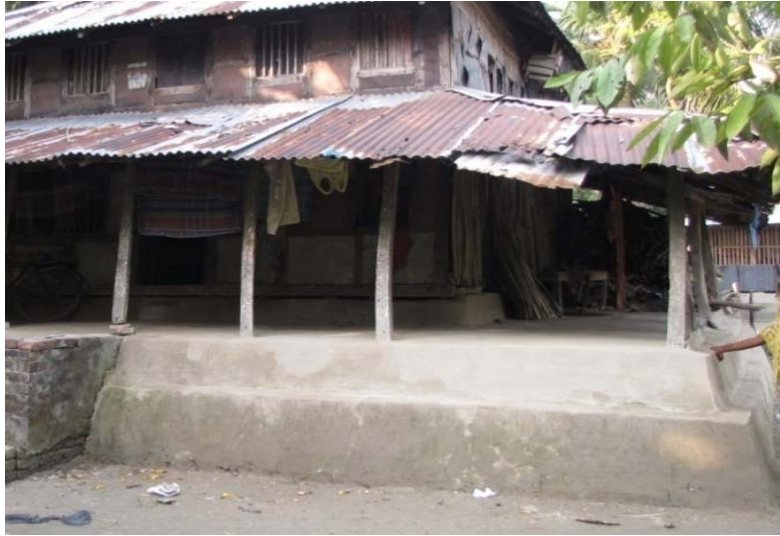
**Photo 2:** Vita of a House (2 storied) in Study Area

Soil is the main material of the floor and *vita*<sup>6</sup> of these two study sites. And average height of vita is 3 feet in both study area. But the southern part of the area's houses' vita is little higher due to closeness of the Burishwar River. There is a relation between vita height and the cyclone water level or flood level. Usually the homestead land is made uplifted than agricultural low land due to flood level that may reach the

house. And the vita is made more higher (normally 3 feet) than the homestead land for extra care. The level is also considering the extensive flood case and also cyclone surges water level.
